# POMPERAUG RIVER WATERSHED Streamwalk Summary Report

# Pomperaug River Watershed Streamwalk Summary Report

February 16, 2014

Jennifer Holton, Principal Ecologist  
of Streamscape Environmental, Keene, NH

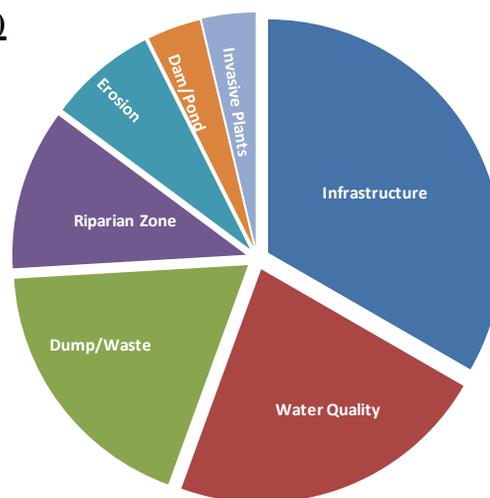
**Figure 8.** Breakdown of Impairments in Local Basin 6800-01-1

***Summary of Concerns:** This local basin has the most infrastructure-related impairments of any local basin in this subwatershed. The upper section of Max Creek is repeatedly channelized and piped. Also on Max Creek, concrete and metal culverts under Sherman Heights Road were reported to be well above low flow levels on the downstream side. Infrastructure concerns on Orenaug Brook included channelization of the stream under Route 6 and under another road in the middle section of the stream. Water quality impairments and dumping were frequently reported in this survey area as well, especially on Orenaug Brook. These impairments included yard wastes, litter, discolored water, sediment, oil slicks, scum, runoff sources, and a large rusted tank.*

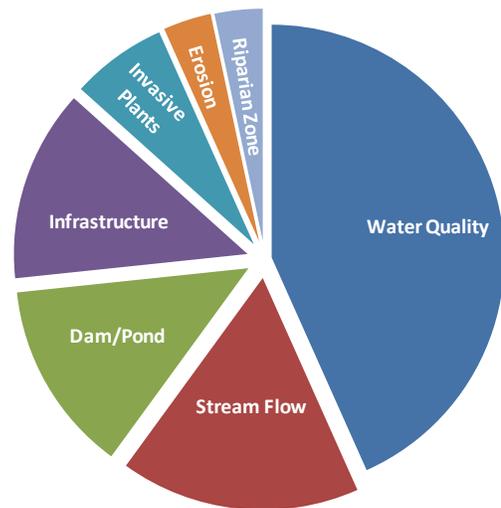
**Figure 9.** Breakdown of Impairments in Local Basin 6800-04-1

***Summary of Concerns:** Water quality-related impairments were the most frequently observed in this local basin, including turbid and oily water from discharge pipes, foam, scum, sewage odors associated with drainage pipes, and runoff sources close to the stream channel. Several dams/ponds and infrastructure related impairments are spread throughout the survey area. Two occurrences of severe bank erosion were reported in one segment. Stream flow levels may be of concern as well, since many segments in this basin were dry at the time of the Streamwalk survey (it is unclear whether these were intermittent streams which typically dry up or whether this was an unusual occurrence).*

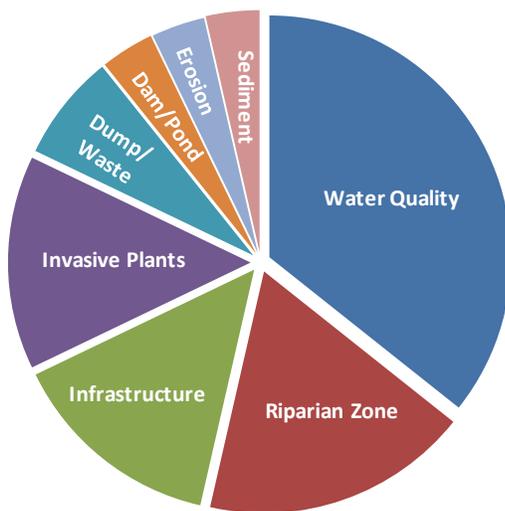
**Figure 10.** Breakdown of Impairments in Local Basin 6800-09-1

***Summary of Concerns:** Water quality-related impairments were the most commonly observed in this survey area, often reported in association with diminished riparian vegetation and infrastructure problems. Invasive plants were prevalent in this survey area: Phragmites and Purple Loosestrife were observed surrounding ponds, in wetlands adjacent to the stream, and along a long stretch of the middle section of the brook. Japanese Barberry was also reported along the middle section of the brook.*

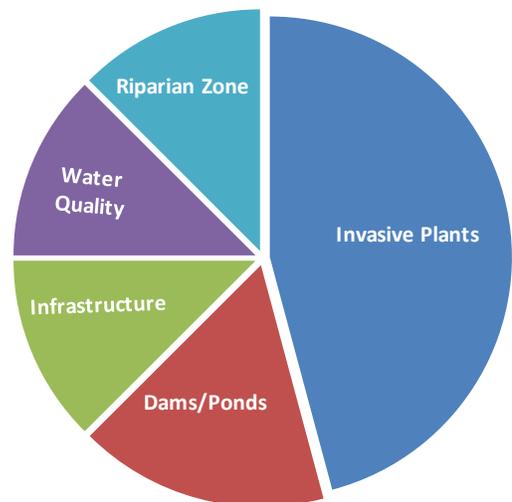
**Figure 12.** Breakdown of Impairments in Local Basin 6802-12-1-L1

***Summary of Concerns:** Invasive plants were the most frequently observed impairments in this local basin (Figure 12). Japanese Barberry and Multiflora Rose were observed along the banks and riparian zones of all three of Cat Swamp Pond's tributaries. In most cases the reports were of isolated plants, small clumps or widely scattered plants. Dams/ponds were the next most frequently observed impairment in this survey area. Aside from the Cat Swamp Pond dam, there were remnants of two small stone and earth dams reported in the upper half of one tributary and one man-made pond on another tributary.*

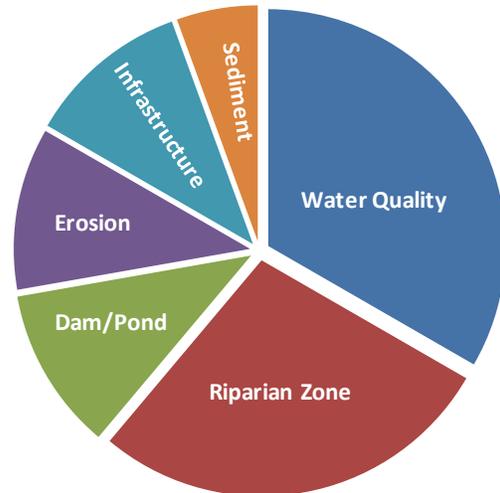
**Figure 13.** Breakdown of Impairments in Local Basin 6802-00-2, 68

***Summary of Concerns:** A variety of water quality-related impairments were reported in this survey area, including discharge pipes, runoff, oily sheen, and excessive algal growth. In segment B there was a horse farm with the fence up to the bank causing heavy erosion and animal waste runoff. In several areas residential lawns or farmland replaced the native riparian vegetation and in other areas the riparian buffer was less than 25 feet wide. Infrastructure-related impairments and diminished riparian zones were found in association with bank erosion in segments A and B.*

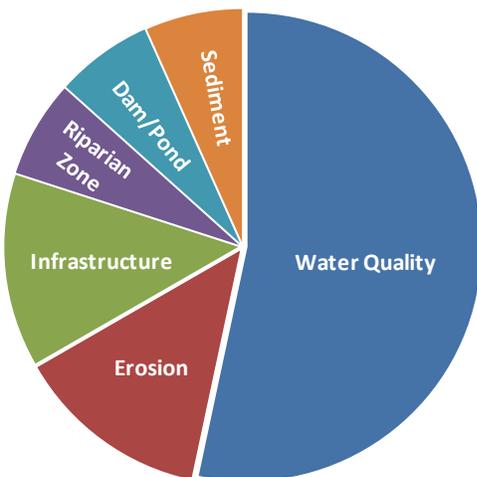
**Figure 14.** Breakdown of Impairments in Local Basin 6802-03-2-R1

***Summary of Concerns:** This section of stream was described as flowing through agricultural areas and paralleling major transportation routes, with some areas of forest intermixed. Runoff from roads and cow pasture are the primary concerns in this survey area. Bank erosion was also observed in and around the cow areas. Foam and oil were observed in one segment near a road. Also noteworthy, a series of stone impoundments, concrete dams, bridges, and riprap located just before the confluence of Lewis Atwood River and the Nonnewaug River were counted as a single impairment. This impairment is noted as causing deeper, warmer, stagnant water with more aquatic vegetation.*

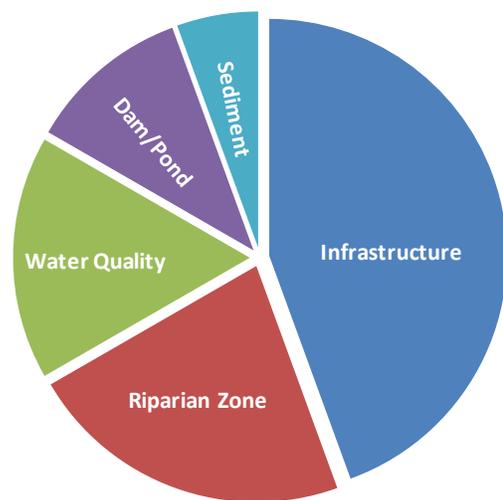
**Figure 16.** Breakdown of Impairments in Local Basin 6804-07-1b

*Summary of Concerns:* The dominant impairments found along this small unnamed tributary are related to infrastructure. Stream manipulation was reported seven times. One section of stream of particular concern was channeled underground after a small impoundment. Another infrastructure problem occurred at Crane Hollow Road, where the stream flows under the pipe culvert, rather than through it, and the water becomes turbid with rusty brown scum just past it. Diminished riparian zones were also noted in several places, with lawns replacing native vegetation in two sites, a clear-cut area, and vehicle tracks disrupting the buffer near the confluence.

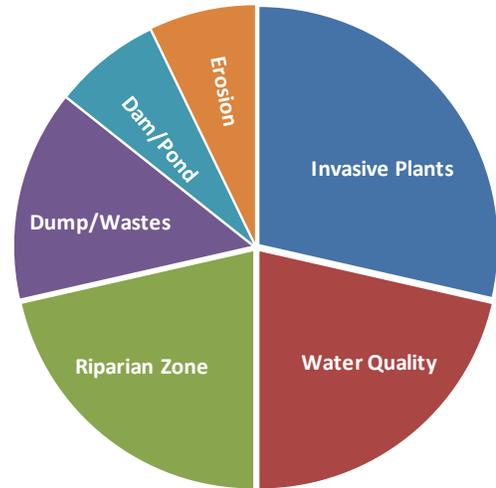
**Figure 17.** Breakdown of Impairments in Local Basin 6804-08-1

*Summary of Concerns:* Invasive plants were the most frequently observed impairment in this survey area. Japanese Barberry was noted in the riparian zones of four of the five stream segments, ranging in extent from a few plants to dominating both banks of a long stretch of stream. Due to residential development, the average buffer width along much of this local basin is less than 25 feet. Water quality is a concern in three sites in this local basin: 1) where livestock have access to the stream, 2) runoff from a new construction site, and 3) two discharge pipes of unknown origin. Bank erosion due to cattle accessing the stream was also reported as a concern.

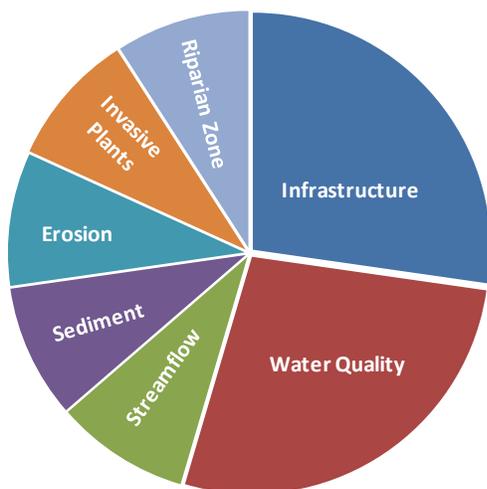
**Figure 18.** Breakdown of Impairments in Local Basin 6804-00-2-R1, 6804-00-1

*Summary of Concerns:* While this section of stream was reported to be generally clean and undeveloped, some infrastructure and water quality concerns were observed. Infrastructure impairments included two sites of channelization (one 50-foot channel through a private lawn and another section channeled for about 200-feet). A clear-cut area used for motocross is causing excessive erosion and runoff concerns. At Todd Hill Road Bridge, the road is crumbling into the stream. Invasive plants, although counted as a single impairment, are a significant concern as well. Heavy Japanese Barberry thickets were observed north of Todd Hill Road, and Japanese Barberry and Multiflora Rose were abundant over the entire study area.

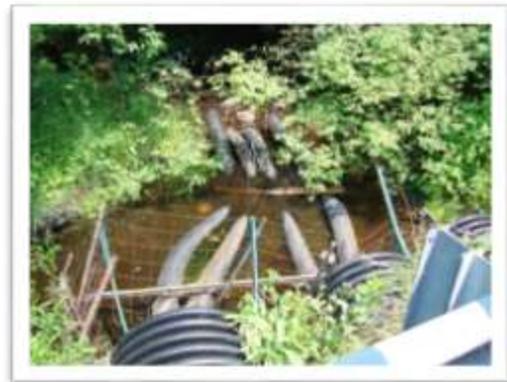
| ✓ High turbidity | ✓ Livestock in stream or |
| ✓ Excessive algal growth | on streambanks |

- Continue the Volunteer Macroinvertebrate Survey program to monitor water quality.
- Develop a water-quality sampling program or incorporate water-quality sampling into the Streamwalk Program (e.g. volunteers could collect samples to send to a lab). **Note: This is in the works and will be launched this summer.**

- Conduct follow-up visits to impairment sites with noticeable signs of water quality degradation to identify causes and determine if restoration actions should be taken.

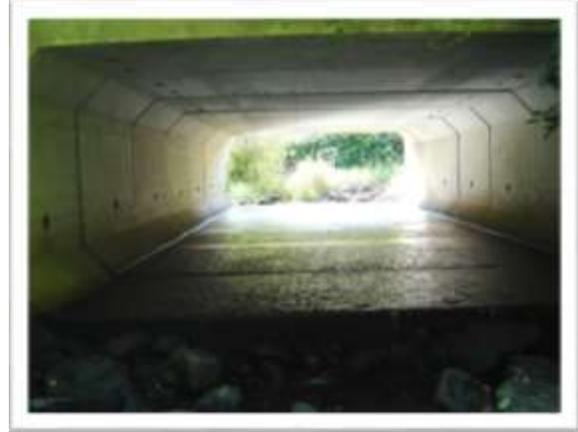
- ✓ Stream manipulation
- ✓ Poor culvert design
- ✓ Channelization
- ✓ Concrete steps
- ✓ Channel armoring
- ✓ Pipes (other than drainage)

- Initiate a watershed-wide culvert assessment. This assessment should take into account stream continuity for fish passage, the natural movement of stream materials and wildlife migration, as well as the durability and effectiveness of the culvert itself, especially in relation to the culverts' capacity to accommodate fluctuating stream flows.

- Report damaged culverts and other road-related impairment to the Highway Department.
- Based on culvert assessment results, prioritize problem culverts for replacement, prepare specifications for good culvert design, and provide this information to the Highway Department for use as the opportunities for replacing problem culverts arise.

- Existing infrastructure in the river corridor limits options and poses challenges to river restoration. Factors such as cost, political acceptability, and overall practicality will need to be evaluated when prioritizing infrastructure-related restoration projects. Efforts to restore impairments caused by infrastructure should be focused on areas where ample space allows for channel movement so that natural form and process can be established.

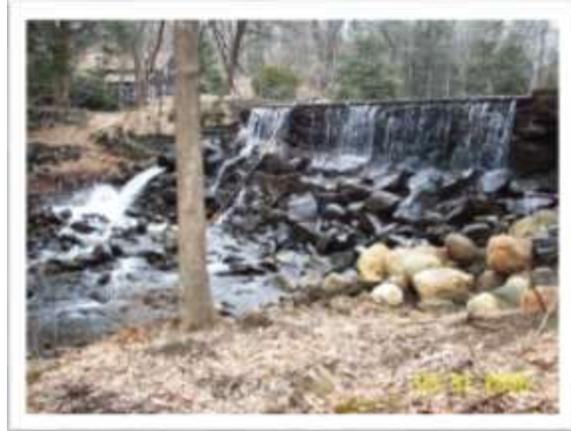
- ✓ Large public works dams / impoundments
- ✓ Small ponds created by stone and earthen dams, many incorporated in to the landscapes of private residences
- ✓ Breached historic dams

- Initiate a watershed-wide dam assessment to determine the degree to which dam structures impede fish passage and restrict natural channel form and process (could easily be combined with the culvert assessment as a connectivity study).
- Develop outreach materials targeted at property owners who have small dammed ponds on their property to educate them about proper maintenance of the ponds for protection of the stream's water quality and habitat connectivity.
- Work with local and state agencies to remove the remaining structures of breached or obsolete dams.

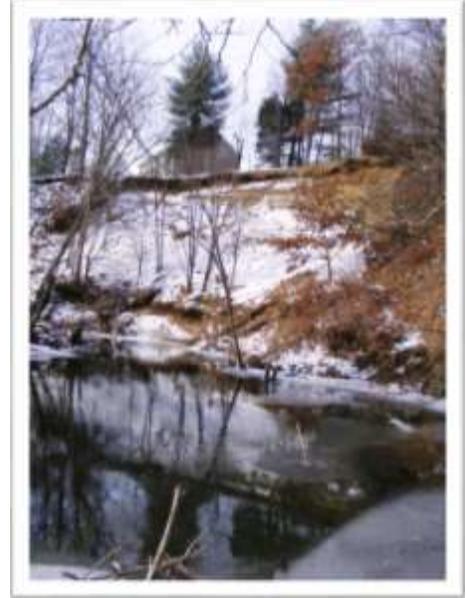
- ✓ Stream bank erosion caused by channel adjustment/migration
- ✓ Livestock trampling streambanks
- ✓ ATV's crossing streams or driving on streambanks.

- Conduct follow-up visits to sites where severe bank erosion was reported to identify whether it is due to natural channel migration or unhealthy stream conditions. If an unnatural cause is identified, develop a restoration plan for addressing both the root cause and stabilizing the stream banks.
- Urge state and local officials to enforce no-trespassing laws for ATVs in the riparian zone.
- Work with agricultural landowners to install and maintain naturally vegetated riparian buffers and livestock fencing.

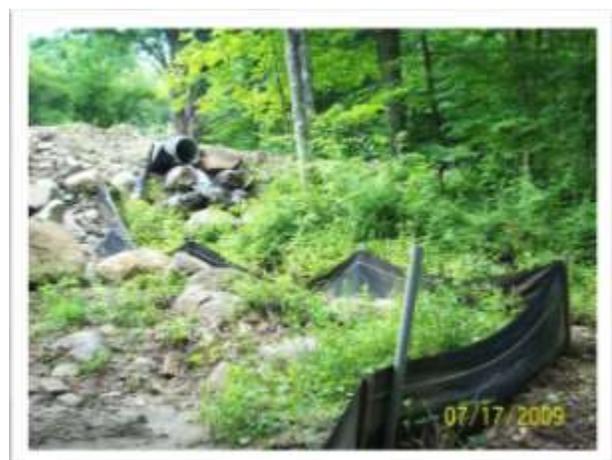
- ✓ Sedimentation and silt accumulation caused by large-scale clearing of vegetation for development, logging, mining, and road building.

- ✓ Inadequate or failing erosion control techniques.

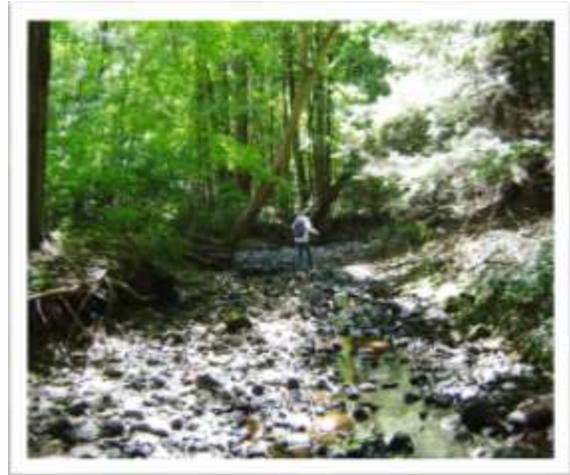
- ✓ Reduced or low stream flow caused by dams, diversions, or withdrawals
- ✓ Dry channels due to reduced base flow

- Confirm permits issued to businesses and residences using or diverting stream water.
- Encourage the use of low-impact development techniques in the watershed.
- Conduct follow-up visits to dry channels to determine if they are natural occurrences or caused by man-made alterations to flow patterns. If they are being caused by man-made alterations, develop a restoration plan for addressing the underlying problem.
